**Flood Control Project Maintenance  
Levee Inspections****LMA District Cover Sheet****Spring 2012 Levee Inspection Results****Reclamation District No. 2094 Wathal**

**Levee Inspection Report By Mile - Spring 2012**

Waterway				Bank	Unit Miles	Inspection Start/End	Inspector
Unit No. 01 San Joaquin River				Right	2.82	05/24/2012 05/24/2012	Max Khashchuk

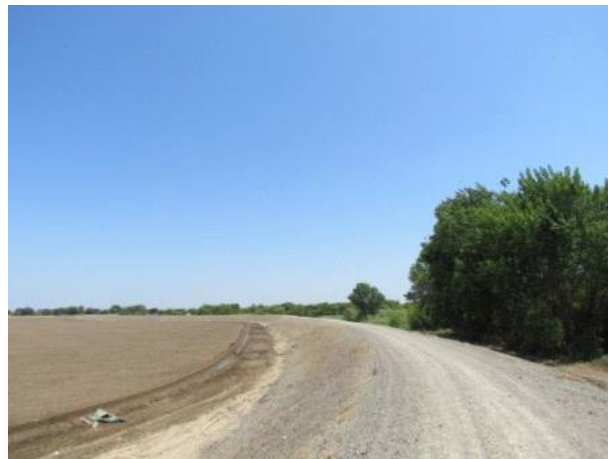
Levee Mile Report Line	5
Start Levee Mile	0.26
End Levee Mile	0.26
Location	Land Side
Category	Earthen Levee
Item	Vegetation
View of well controlled annual vegetation.	
05/24/2012	
mkhashch_s_20120525_407.jpg

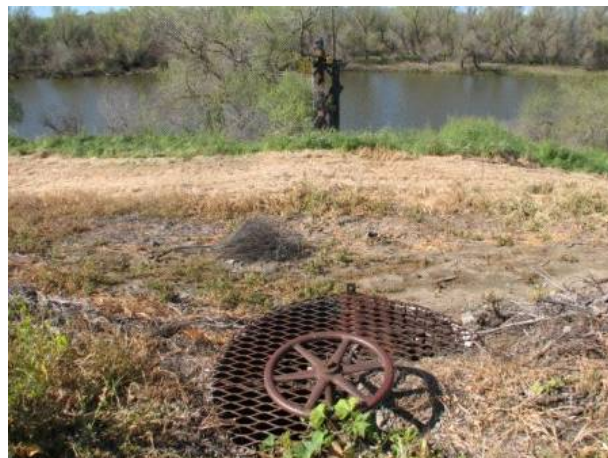
DWR ID: DWR_RD2094_01_s_2012_5										
6	0.66	0.66	Earthen Levee	Encroachments	WSA/W	PI : Pipe Ma	Inspector Comments: 14" steel irrigation intake with sluice gate.	37.767505 ° -121.294902 °	37.767505 ° -121.294902 °	1 Y
DWR ID: DWR_RD2094_01_s_2012_1										
7	1.26	1.26	Earthen Levee	Encroachments	WSA/W	PI : Pipe Ma	Inspector Comments: 20" irrigation intake, sluice gate on water side hinge point.	37.760574 ° -121.297365 °	37.760574 ° -121.297365 °	2
DWR ID: DWR_RD2094_01_s_2012_2										
8	2.29	2.29	Earthen Levee	Encroachments	WSA/W	PI : Pipe Ma	Inspector Comments: 20" steel irrigation intake.	37.752225 ° -121.296431 °	37.752225 ° -121.296431 °	3
DWR ID: DWR_RD2094_01_s_2012_3

Levee Mile Report Line	6
Start Levee Mile	0.66
End Levee Mile	0.66
Location	Water Side
Category	Earthen Levee
Item	Encroachments
Irrigation intake on San Joaquin River. Positive closure device (sluice gate) on water side hinge points. Pipe is through freeboard portion of levee. Concrete stand pipe beyond landside toe.	
mkhashch_s_20120511_081.jpg

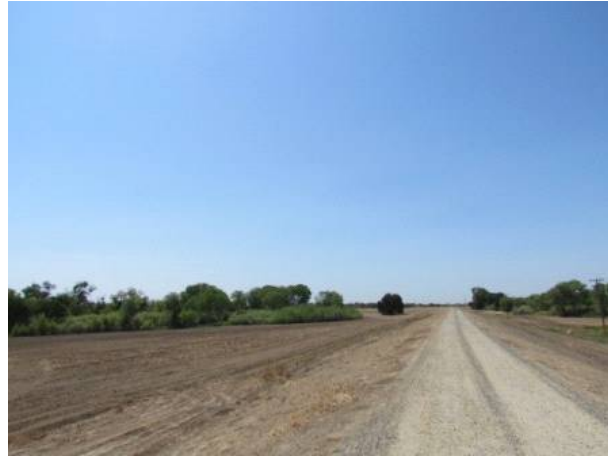
Levee Mile Report Line	1
Start Levee Mile	0.02
End Levee Mile	0.02
Location	Water Side
Category	Earthen Levee
Item	Vegetation

LMR No.	Levee Mile		Category	Item	Location *	Rating ** +	Action/Comment	GPS Latitude/Longitude		Issue No. Photo
	Start	End						Start	End	
1	0.02	0.02	Earthen Levee	Vegetation	WS	A	V1 : Control annual grass and weeds on the levee slopes and easements.	37.759377 ° -121.300010 °	37.759377 ° -121.300010 °	1 Y

View of well controlled annual vegetation.  
05/24/2012
